North Philadelphia Interlocking

Track Improvements Necessitate Replacing Old
Electro-Pneumatic Plant; All-Electric Type Used

By W. M. POST,
Supervisor of Signals, Pennsylvania R. R.

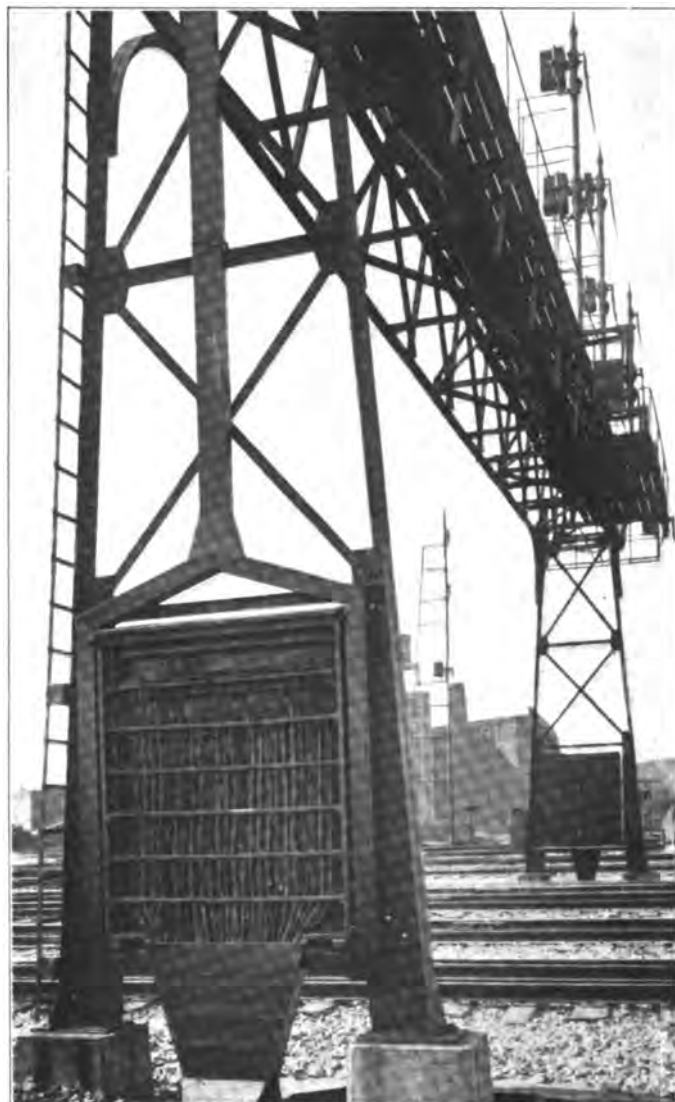
Fig. 9. Rear of Relay Box with Back Removed, Showing Arrangement of Wires and Cables.
